**CREEP-RUPTURE BEHAVIOR OF A WOVEN CERAMIC  
MATRIX COMPOSITE AT ELEVATED TEMPERATURES IN  
A HUMID ENVIRONMENT**

THESIS

Jennifer L. Ryba, 2<sup>nd</sup> Lieutenant, USAF  
AFIT/GMS/ENY/06-M02

**AIR FORCE INSTITUTE OF TECHNOLOGY**

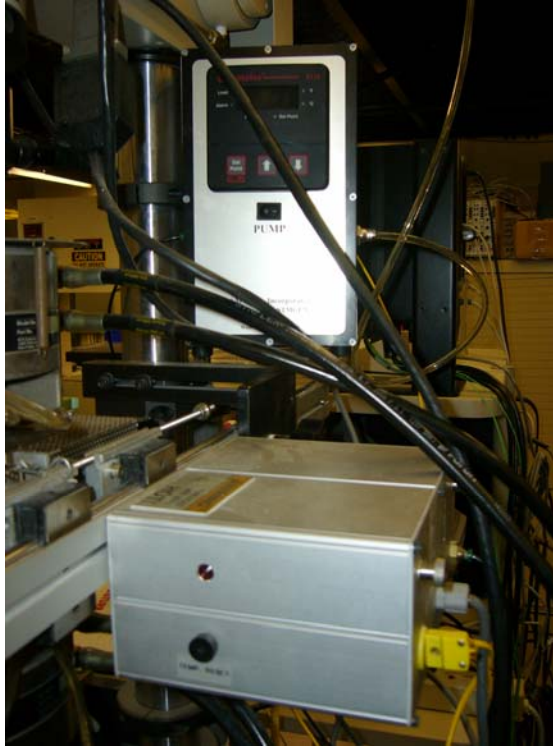
**Figure 15: Water Pump and Steam Heating Unit**

Two components were required to provide steam for the test, a water pump, and a steam heating unit. These components made up the AMTECO HRFS-STMGEN Steam Generation System. The unit pumped approximately 30 mL/h into the susceptor. The system used distilled water contained in a jug set above the testing unit. The water traveled first through the pump, then the steam heating unit, and from that unit through a ceramic feed tube into the susceptor. A slight positive pressure removed the dry air from the susceptor, and allowed for a 100% steam environment. Figure 15 shows the water pump and steam heating unit.

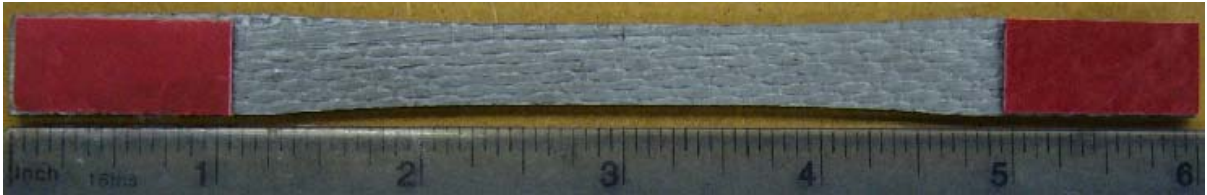
**Figure 16: Tabbed Specimen**

specimen ends induced by the grips. The tabs also protected the specimen from surface damage caused by the grips. The tabs consisted of a glass fabric/epoxy material. The tabs were glued to the specimen using M-Bond Catalyst. 3 drops were applied to each surface, and then pressure was applied for about a minute, to ensure good contact between the tab and the specimen. Figure 16 shows a tabbed specimen.

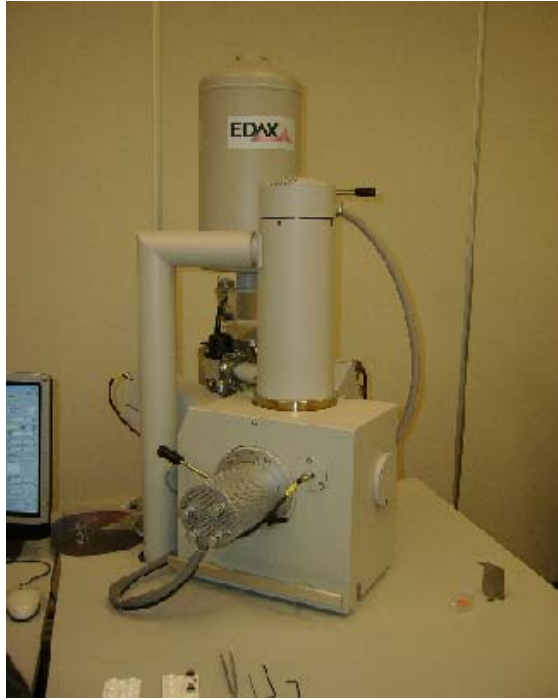
**Figure 17: Scanning Electron Microscope**

The SEM used to analyze the specimens for this experiment was a FEI FP 2011/11 Quanta 200 HV Scanning Electron Microscope shown in Figure 17. The SiC/SiC specimens were relatively good conductors, and while the pictures did show some charging in the specimen, the results were not distorted enough to require coating the specimens.
